LAKE SCRANTON DAM
PENNSYLVANIA GAS AND WATER COMPANY

PHASE I INSPECTION REPORT
NATIONAL DAM INSPECTION PROGRAM

MAY 1978

6 National Dam Inspection Program.
Lake Scranton Dam (NDS ID 374),
Susquehanna River Basin, Stafford Meadow
Brook, Lackawanna County, Pennsylvania.
Phase I Inspection Report.

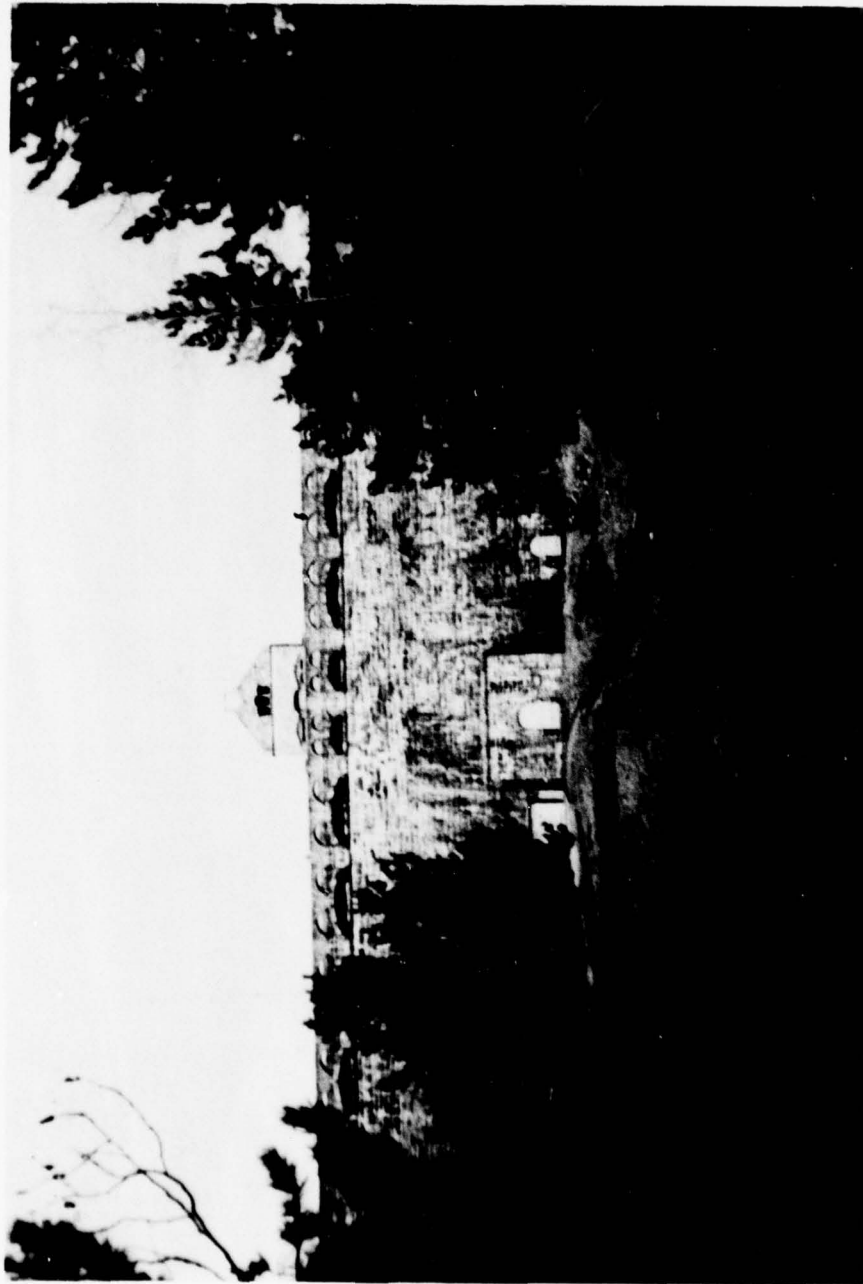
Lake Scranton Masonry Gravity Dam,
Auxiliary Spillway Arches,
Screen Chamber Building, and Gatehouses
Looking Upstream

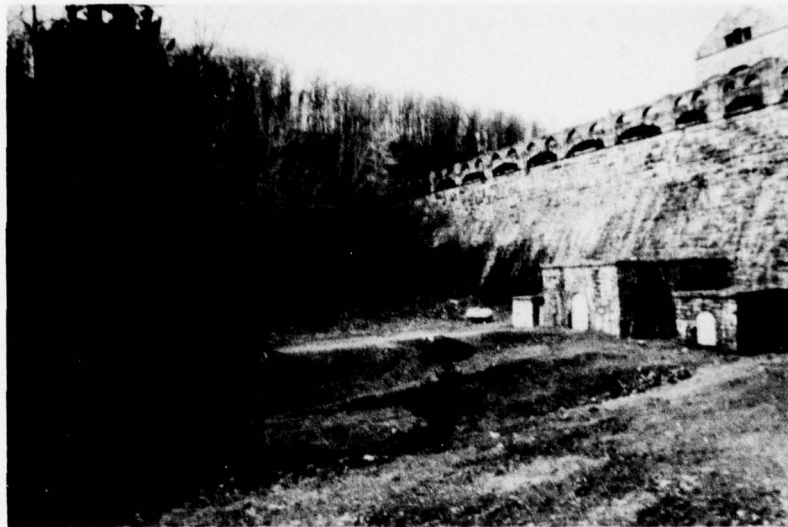
(2) Several damp areas and seepage points were observed on the downstream face of the masonry gravity section of the main dam. However, at no place was the leakage estimated to exceed about 1/4 gallon per minute, and no damage or other adverse effects have resulted from the leakage. The stone masonry and mortar joints were in excellent condition, and they had no signs of weathering, cracking, or other defects. The auxiliary spillway consists of a series of arched openings through the upper portion of the masonry gravity dam. Photographs A and B show the downstream face of the dam and the auxiliary spillway.

A. Right Abutment and Right Side of
Masonry Gravity Dam

(8) Visually monitor leakage quantity on downstream face of masonry gravity section of main dam and make repairs when necessary.

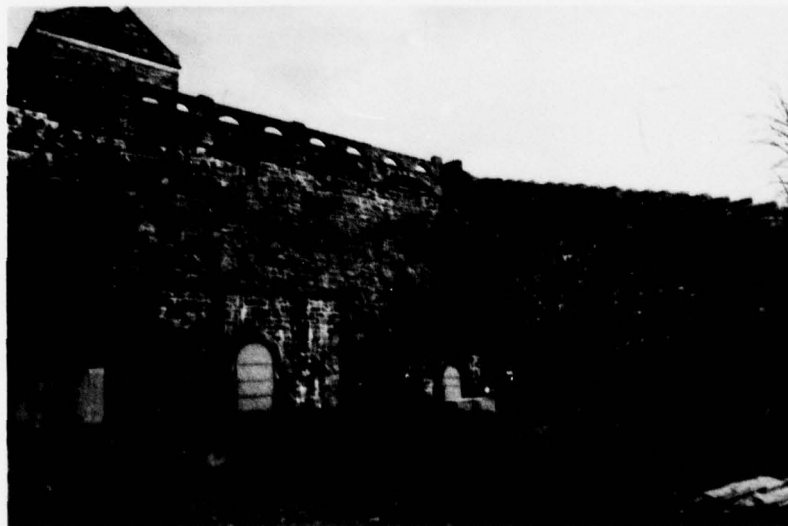
B. Left Side of Masonry Gravity Dam
and Embankment Retaining Wall

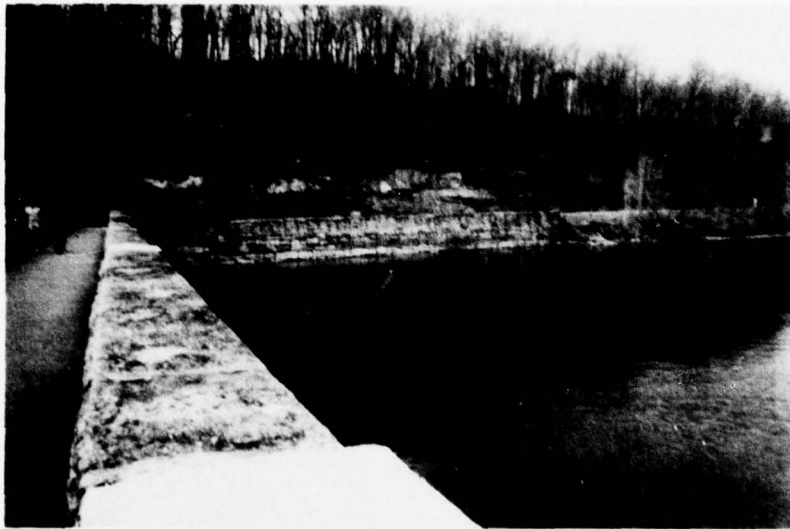
C. Right Bank Roadway Retaining Wall
Upstream of Masonry Gravity Dam

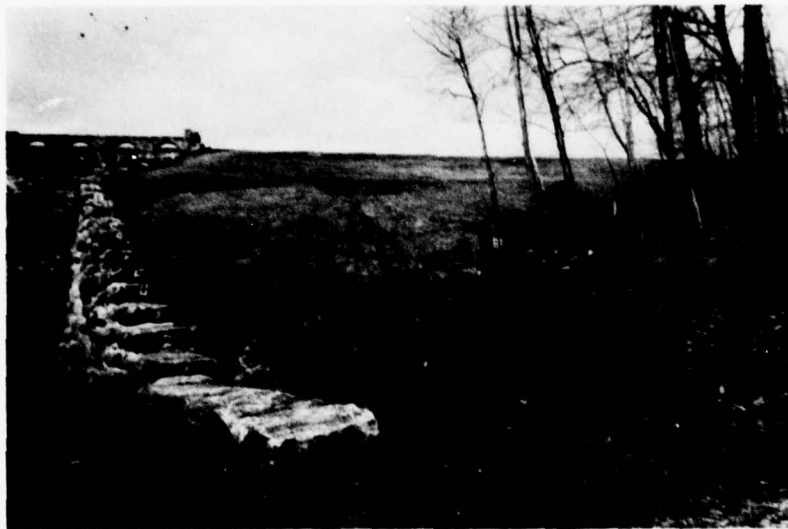
(3) The embankment section adjacent to the masonry gravity dam was covered with a good growth of sod and was well maintained. The downstream slope is irregular, but is approximately 1V on 3H. At the toe of the slope adjacent to the masonry retaining wall, there was a wet area about 20 feet square (Photograph E). The Owner, while repairing the wall in 1977, installed a gravel drain behind the wall and

connected it to a gravel filled sump at this location. The wet area is overflow from this sump. The overflow, while uncontrolled, has not caused damage to other features.

(3) Water from the subsurface drain behind the masonry retaining wall enters a gravel filled sump. Apparently, the seepage at the toe is a result of the sump being filled to capacity and overflowing. The exact source of this subsurface water is unknown, and the quantity of water and extent of saturation are also unknown. This condition is of general concern because of the proximity to important features.

(2) Embankment Section of Main Dam. A seepage area was observed at the toe of the embankment. The detailed description and evaluation of the condition are in Paragraphs 3.1.b.(3) and 3.2.a.(3), respectively.

E. Wet Area in Vicinity of
Drainage Collection Sump

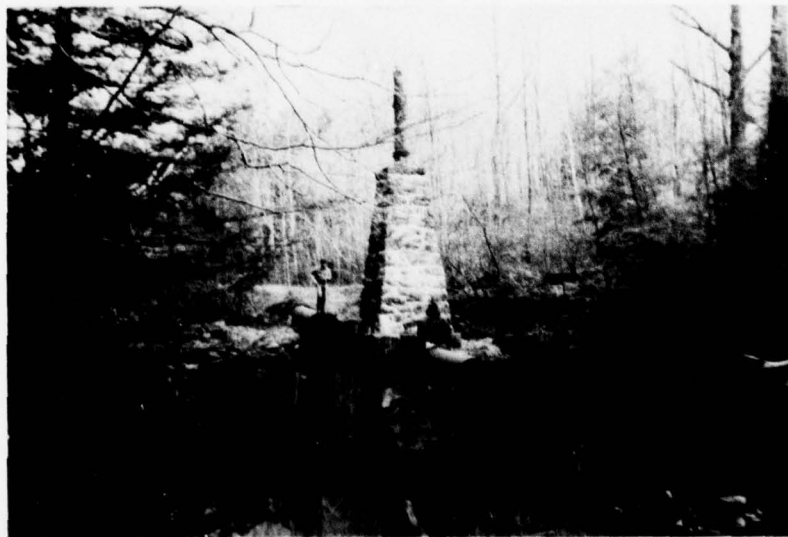
F. 36- and 24-Inch Emergency Reservoir Drawdown Outlets
Below Dam

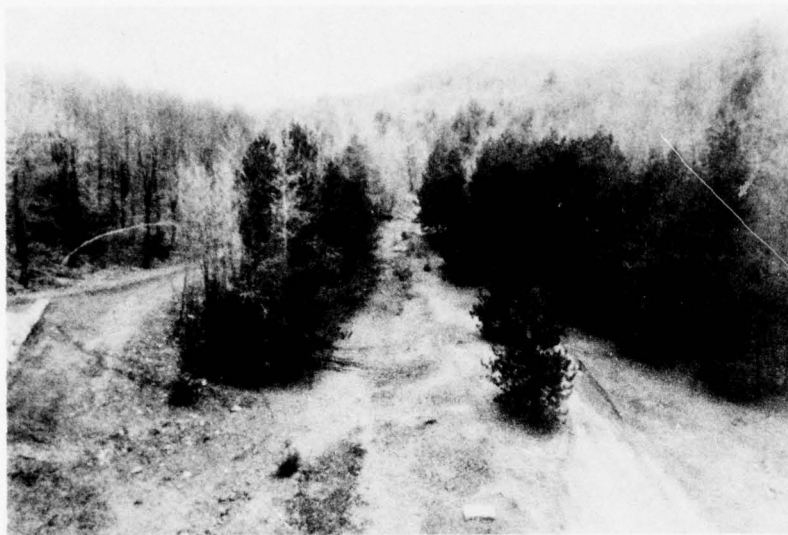
G. Downstream Channel Below
Masonry Gravity Dam

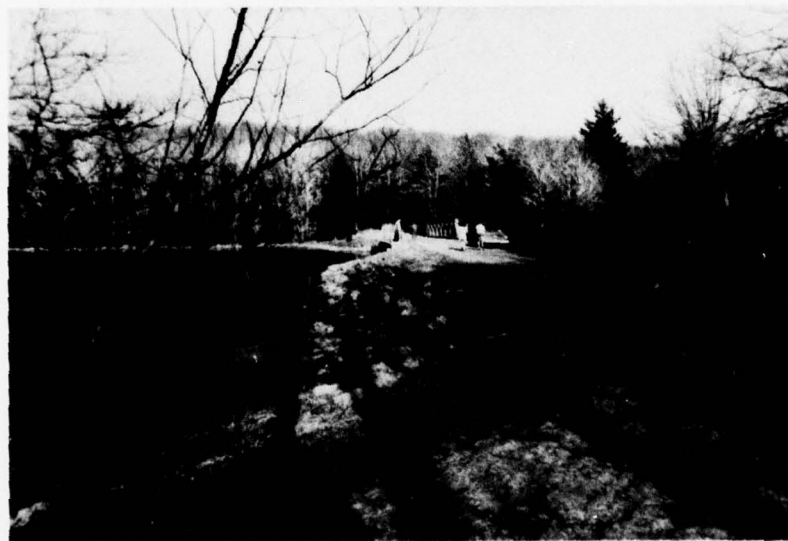
(1) The embankment sections that are adjacent to the main spillway are generally in good condition (Photograph H). No seepage, wet areas or other deficiencies were observed anywhere on the embankment. The sod is intact and well maintained. There has been some loss of riprap at the main spillway abutments. The Owner stated that people who use the roadway as a hiking path throw the stone into the lake. Minor sloughing and erosion has resulted from the loss of riprap. Four small shrubs were growing on the upstream face, and two 4-inch trees were growing on the downstream face left of the spillway (Photograph K). The downstream embankment slopes are 1V on 3.5H to the right of the spillway, and 1V on 1.5H to the left of the spillway. Heavy forest begins at the toe of the embankment to the left of the spillway and about ten feet beyond the toe to the right of the spillway. A survey of the top of the embankment showed that the left end was 4 feet higher than the right end. The survey also showed that the right end of the embankment, which is at Elevation 1286.1, is the lowest top of dam elevation for the project. Consequently, overtopping would occur at this location first.

H. Bridge Over Main Spillway and
Adjacent Embankment Dam

(4) Replace missing riprap and remove shrubs on upstream surface of embankment adjacent to main spillway.

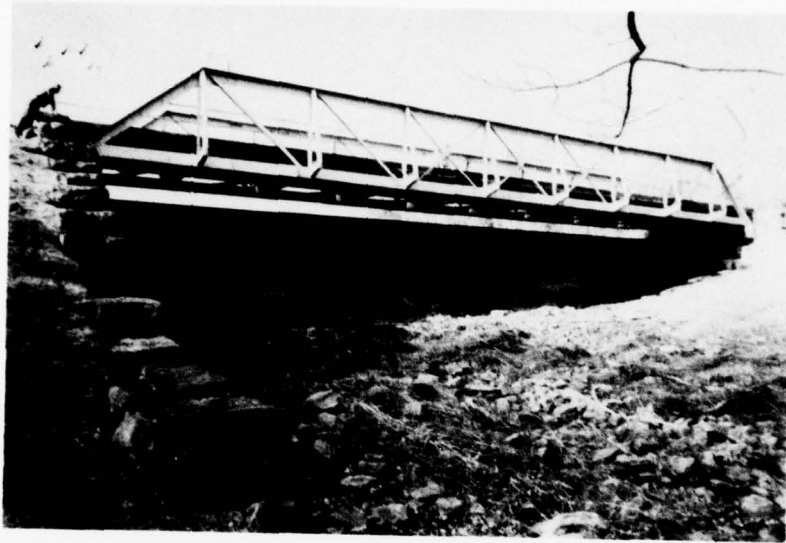
e. Downstream Channel. The channel immediately below the main spillway is covered with large, loose rock and was dry (Photograph I). Several hundred feet downstream, discharge from some small springs converge to form a small permanent watercourse through the dense forest. The channel below the gravity dam was also dry for several hundred feet. It is very irregular, and the forest starts about 300 feet downstream (Photograph G). The two channels converge well downstream of the dam. A gas tank, which the Owner thought contained propane, is located in the downstream channel area near the toe of the gravity dam.

I. Main Spillway and Bridge over Crest
Looking Upstream

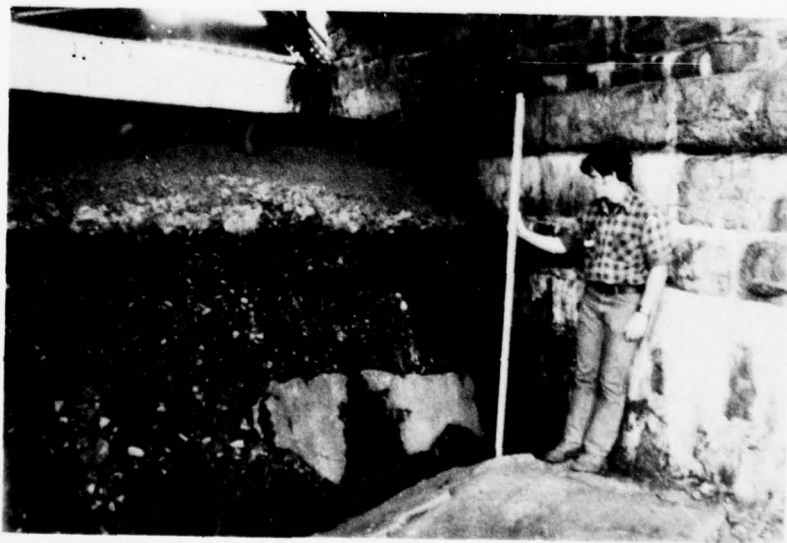
(1) The main spillway is suffering from advanced concrete deterioration (Photograph J). The concrete was placed in 1916 and was doweled to the existing masonry gravity spillway to ensure the stability of the structure. About 2/3 of the downstream face has very severe scaling to a maximum depth of about 7 inches. At the left end, 1-foot lengths of the steel reinforcement are exposed and are in early stages of corrosion. Wide horizontal cracks are present at most of the construction joints, and they are weathered and scaled to a maximum depth of 10 inches. Leakage from these joints was observed, particularly at the first joint below crest level. The most concentrated leakage point had an estimated flow of 2-3 gallons per minute (Photograph J, p.D-5). The leakage has not affected other features. Two lines of 1-1/2-inch diameter drain holes, totalling 33 holes, are on the downstream face, but discharge from them ranged from slight to nothing. A roadway bridge across the spillway crest has its low steel about 2.5 feet above the crest (Photograph I).

(1) The concrete on the main spillway, particularly on the left side, has deteriorated to the extent that its structural integrity could be affected. Examination of previous inspection records shows that the deterioration began at least as early as 1933. The location of the bridge over the main spillway is such that it might act as a hydraulic constraint when the depth of water over the crest exceeds 2.5 feet. It could also cause a buildup of debris during floods.

(3) Main Spillway. The concrete on the main spillway is deteriorated. The detailed description and evaluation are in Paragraphs 3.1.c.(1) and 3.2.b.(1), respectively.

J. Damaged Area at Left End of
Main Spillway

(2) Perform additional studies to more accurately ascertain the spillway capacity required for Lake Scranton Dam as well as the nature and extent of mitigation measures required to make the spillways hydraulically adequate. Also include provisions to repair concrete of the main spillway.

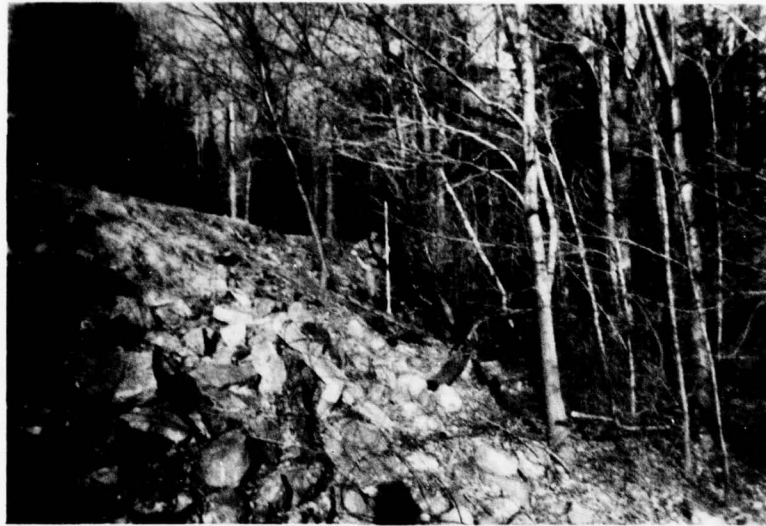
(1) The continued growth of trees and shrubs on the embankment slopes and along the toe of the embankment is undesirable. The downstream slope of the embankment to the left of the main spillway is steep, but the embankment height at this section is not great, and, also, the left end of the dam is considerably higher than the right end. The right end of the dam is the lowest top of dam elevation, and overtopping would occur there first. Unless the lost riprap on the upstream surface is replaced, the upstream slopes adjacent to the spillway will progressively erode and slough.

K. Downstream Surface of Embankment
to Left of Main Spillway

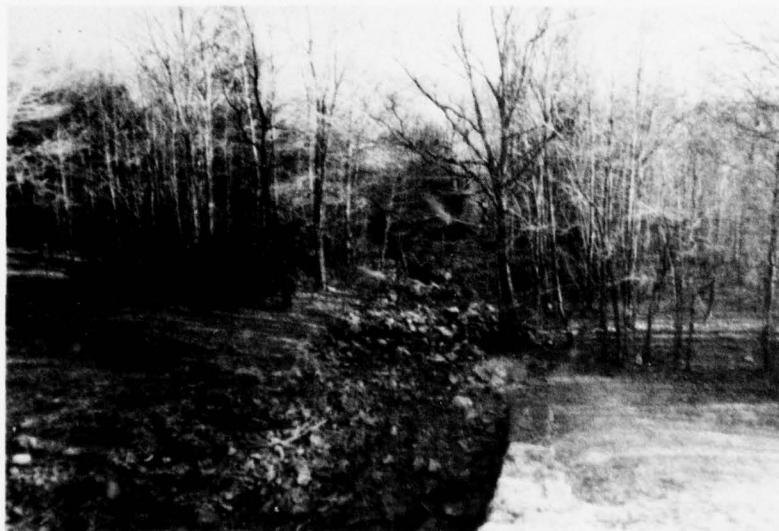
L. Downstream Channel Below
Main Spillway
